HUGHES TOOL COMPANY · AIRCRAFT DIVISION
Culver City, California

Report 285-9-8 (62-8)

HOT CYCLE ROTOR SYSTEM
RESULTS OF COMPONENT TEST PROGRAM

FINAL REPORT

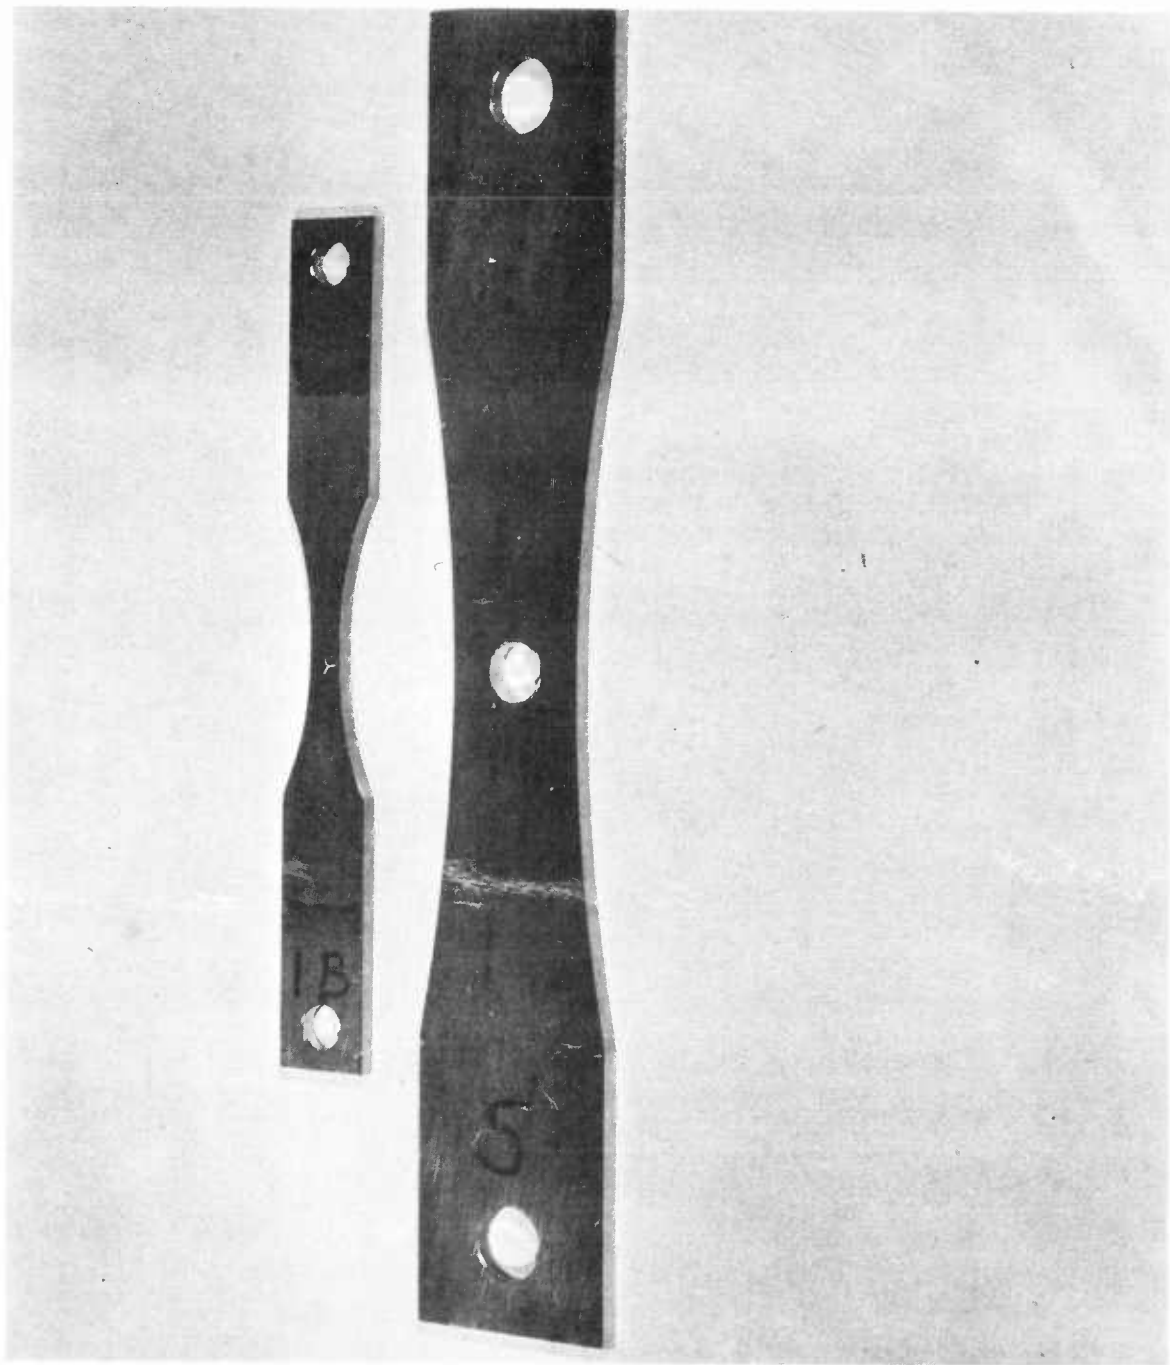
Figure 3-24. Aft Spar Titanium Fatigue Specimen Configuration

b. Fatigue Coupon Tests. Fatigue specimens were machined from material adjacent to the fracture area in a longitudinal direction. The specimens were subjected to tension-tension type loading in a resonant-beam fatigue machine. Two types of specimens were tested. The first type consisted of smooth specimens to check the endurance limit of the aft spar. The second type of specimens contained a hole at the reduced section. This hole was machined with a burr in an attempt to duplicate the hole conditions in the test spar. Other specimens of this type were radiused with a rubber impregnated abrasive to compare the fatigue life of the two hole conditions. The two specimen configurations are shown in Figure 3-24. The two hole conditions are shown in Figures 3-25 and 3-26.
